Facility Condition Assessment Services

Facility Condition Assessment

**For
City of Los Altos
Bus Barn Theater
97 Hillview Avenue
Los Altos,
California 94022-3740**

Date of Report: June 10, 2016

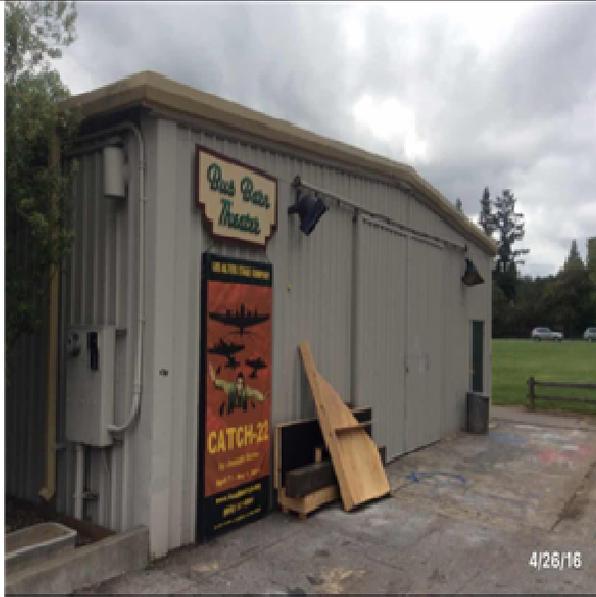
The building's exterior roof cladding appeared to be in poor - fair condition with generally no major signs of deterioration, water ingress or obvious bulging noted, from the inside. The roof was not observed externally due to the issue of access; no anticipated actions will be necessary. The exterior metal panels will likely need repainting near mid-term in the study period.

B1022 Pitched Roof Construction:- View of Pitched roof construction

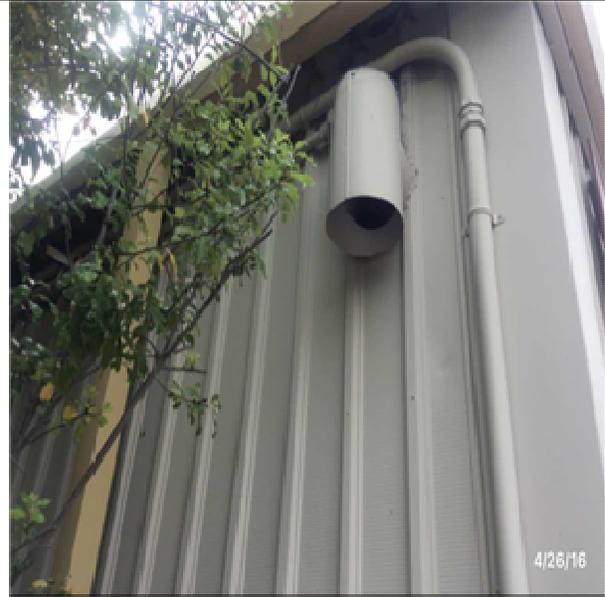
The building's exterior wall system appeared to be in poor - fair condition with generally no major signs of deterioration, water ingress or obvious bulging noted; no anticipated actions will be necessary. The exterior metal panels will likely need repainting near mid-term in the study period.

B2011 Exterior Wall Construction:- View of Cladding - Preformed Corrugated Metal Wall Panels

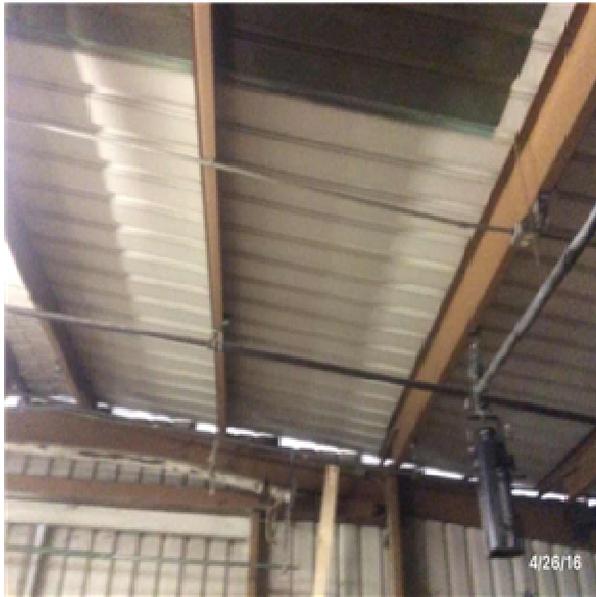
B1031 Steel Frame Structure:- View of Structural Steel Columns and Beams Frame

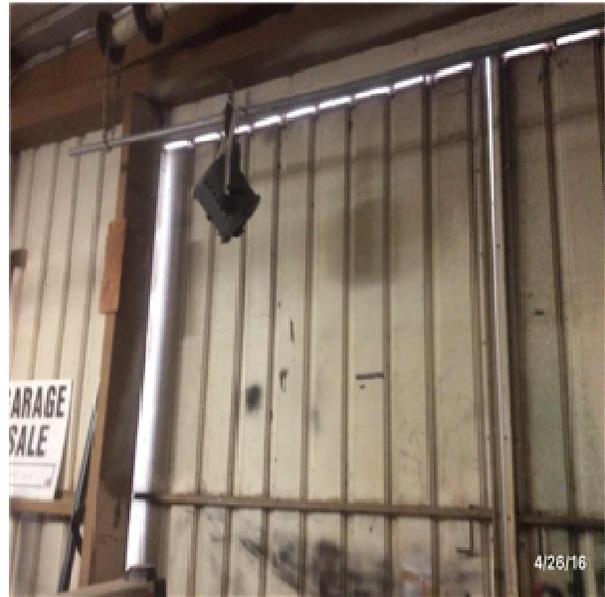
The hangar doors appeared in poor - fair condition and functioned properly with no reported issues; therefore, no replacement actions are anticipated during the study period. The exterior metal panels will likely need repainting near mid-term in the study period at the same time as the building exterior.

B2034 Overhead Doors:- View of Hangar Doors - Top Rolling

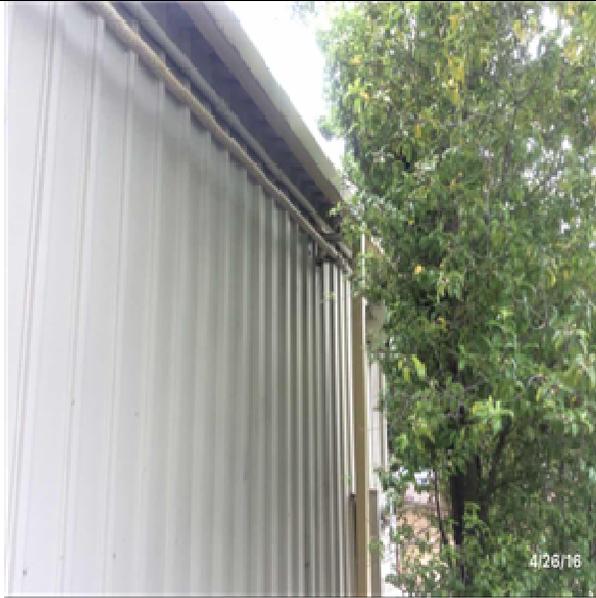
B2011 Exterior Wall Construction:- View of Cladding -
Preformed Corrugated Metal Wall Panels

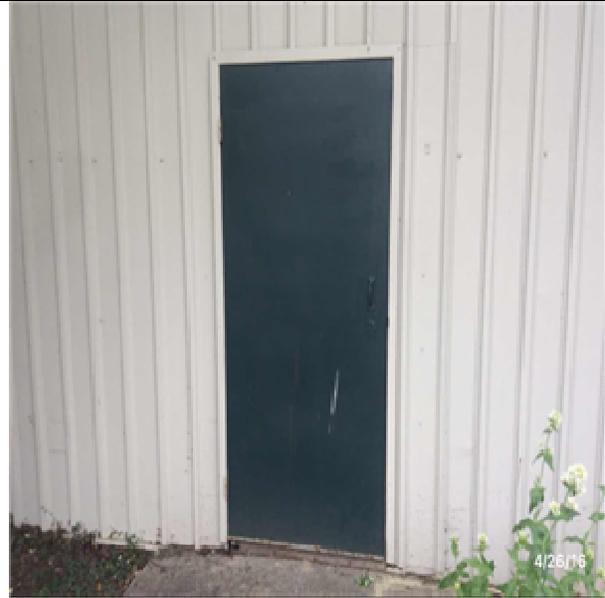
The hollow metal doors appeared to be in poor - fair condition with no major signs of damage or deterioration. There were no issues with these doors therefore no actions will be generated during the study period. The new door surface finish and door frames will require repainting later in the study period. The cost of this work has been included within the amount to undertake the repainting of the exterior walls.

B2039 Other Doors & Entrances:- View of Exterior Single
Hollow Metal Door(s)

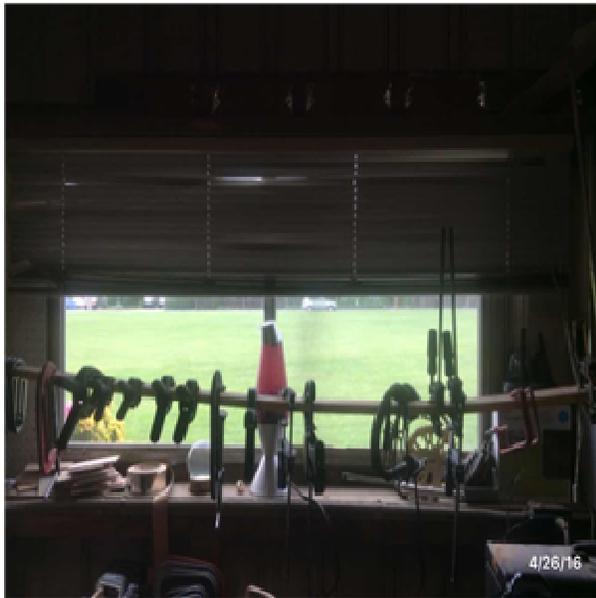
The window systems appeared to be in poor - fair condition. We noted some deterioration of frame and/or glass which would require actions and the frames are over their EUL of thirty years, therefore we recommend replacement during the study period.

B2021 Windows:- View of Aluminum Window Units - Fixed or
Single Hung

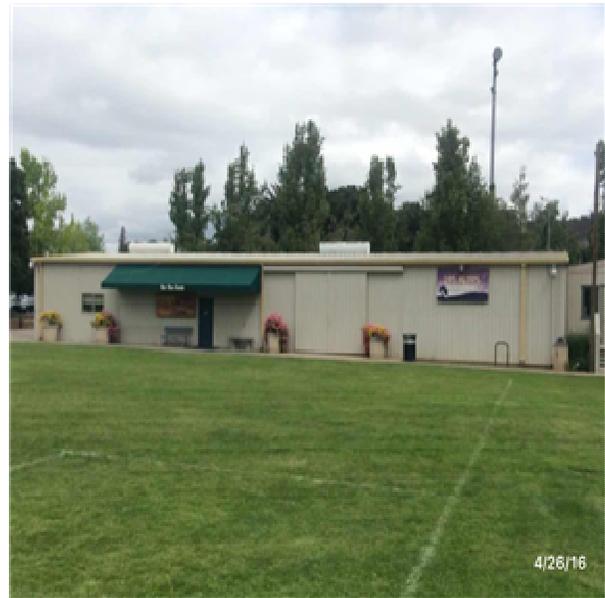
B3011 Roof Finishes:- View of Preformed Corrugated Metal
Roof Panels

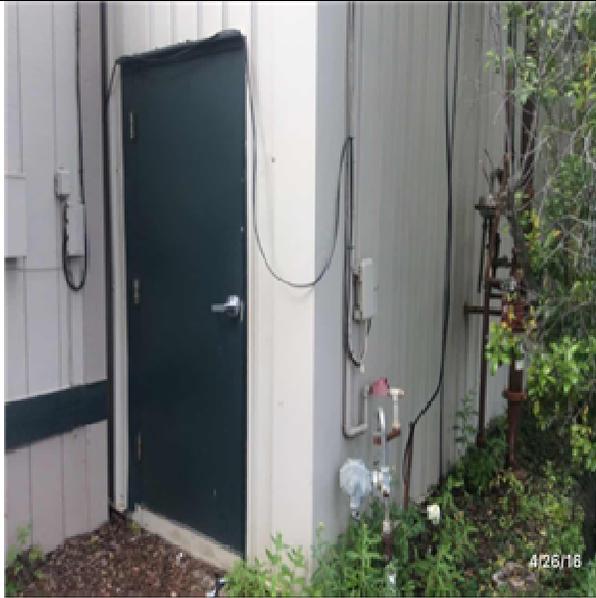
B2039 Other Doors & Entrances:- View of Exterior Single Hollow Metal Door(s)

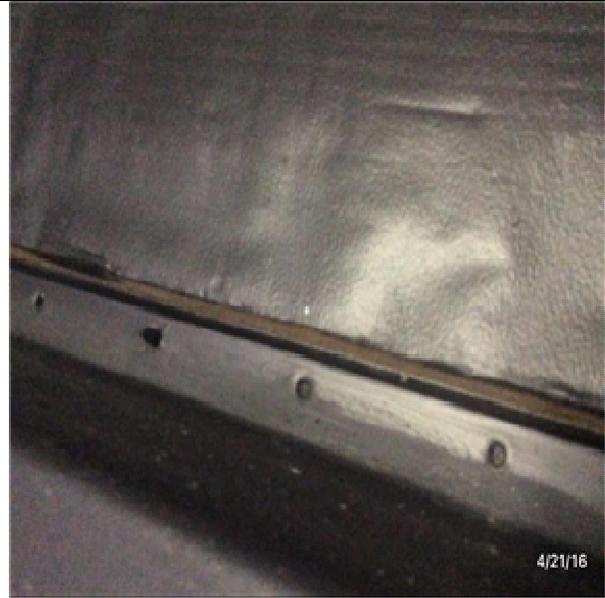
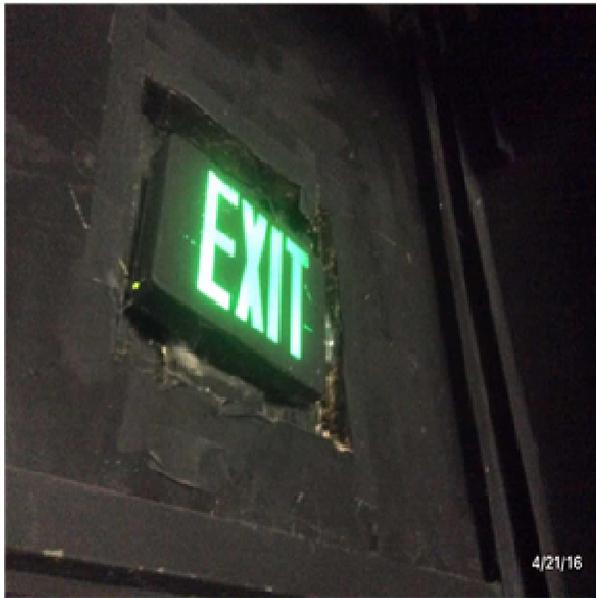
The insulation is in a fair condition, however, assuming the boards were installed when the theater was refurbished in the mid 90's and based on an EUL of 20 years, we recommend the boards are early in the study period.

B3013 Roof Insulation & Fill:- View of Rigid Board Insulation

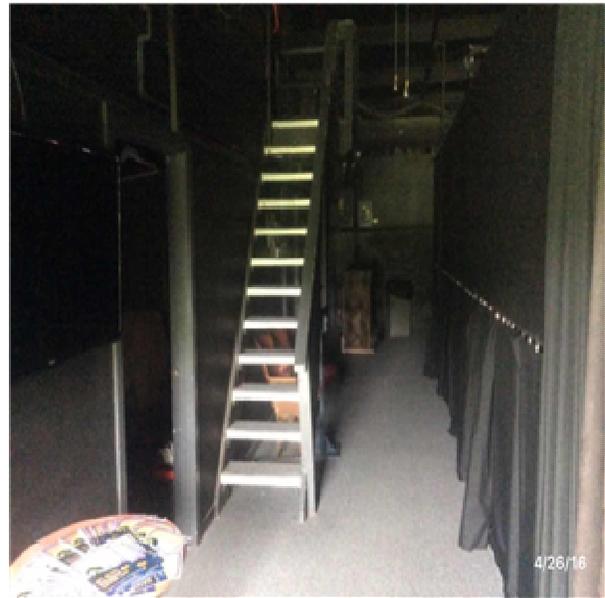
C2011 Regular Stairs:- View of Regular Stairs - Wood Construction

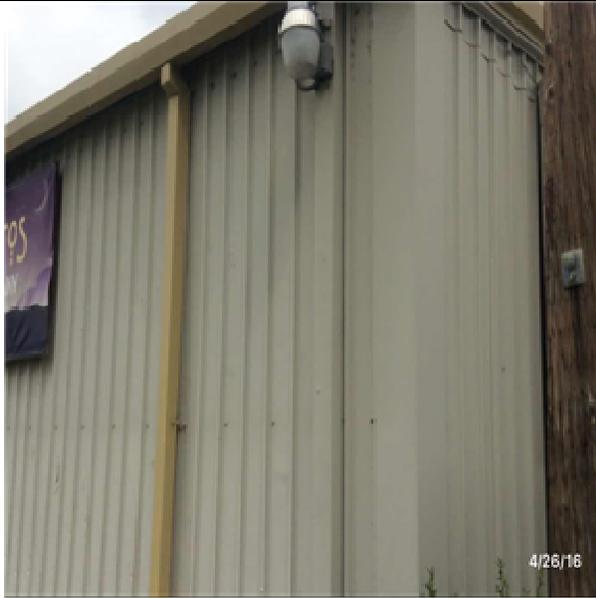
The gutters appear in poor - fair condition. . The typical EUL for this type of gutter system is twenty years; therefore, we recommend replacing the gutters and downspouts during the study period.

B3016 Gutters and Downspouts:- View of Galvanized Steel Perimeter Gutters & Downspout

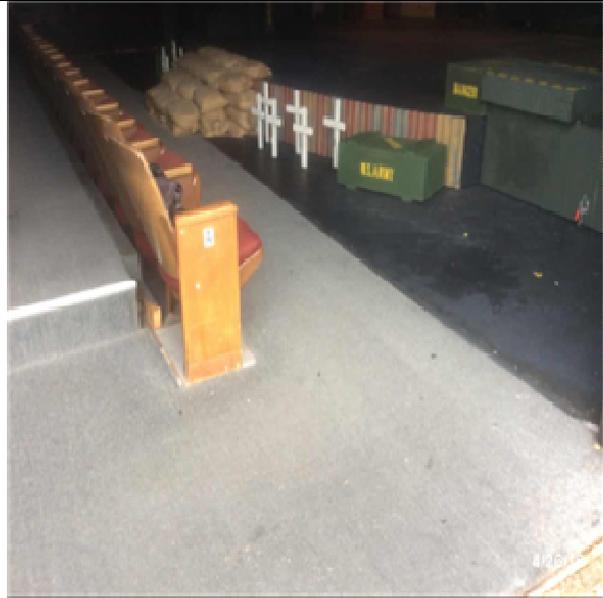
The carpet is in poor condition. We are unaware of the age of the carpeting, however we assume it was when the theater was refurbished in the mid 90's and is likely to be more than fifteen years of age, therefore based on the typical EUL of ten years for this type of covering and current observed condition, we anticipate replacement early in the study period.

C3025 Carpeting:- View of Carpet

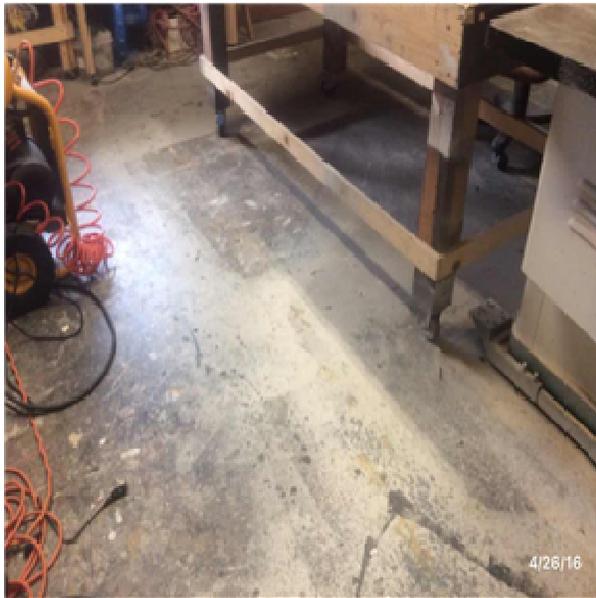
The floor finishes appeared in poor - fair condition throughout the building. We are unaware of the age of the painted finishes, however we assume they were last painted when the theater was refurbished in the mid 90's and they are likely to be more than fifteen years of age, therefore based on the typical EUL of five - ten years for this type of painted finish and current observed condition, we anticipate replacement early and again later in the study period.

C3023 Hardeners and Sealers:- View of Seal Floor Coating

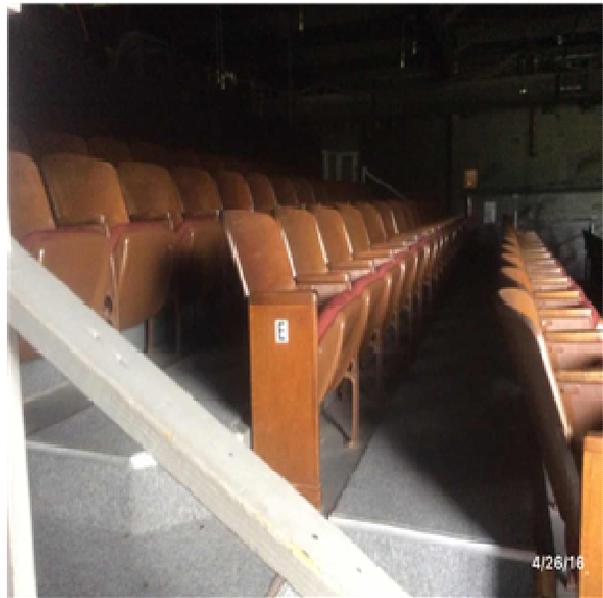
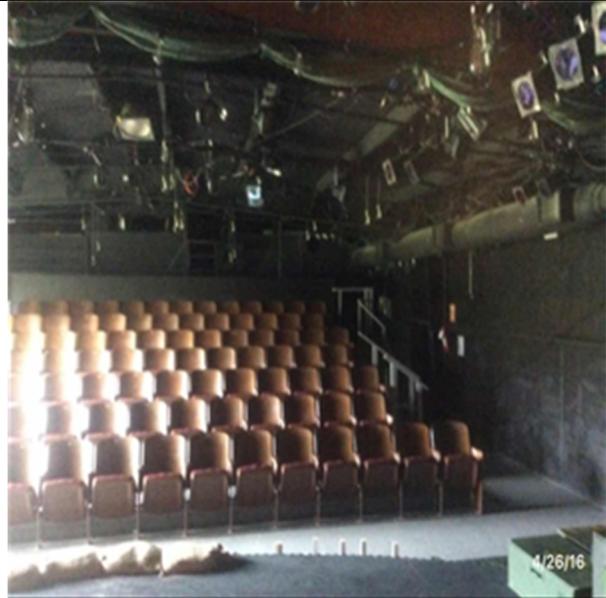
E2015 Fixed Multiple Seating:- View of Seating, Auditorium Chair, Fully Upholstered, Spring Seat

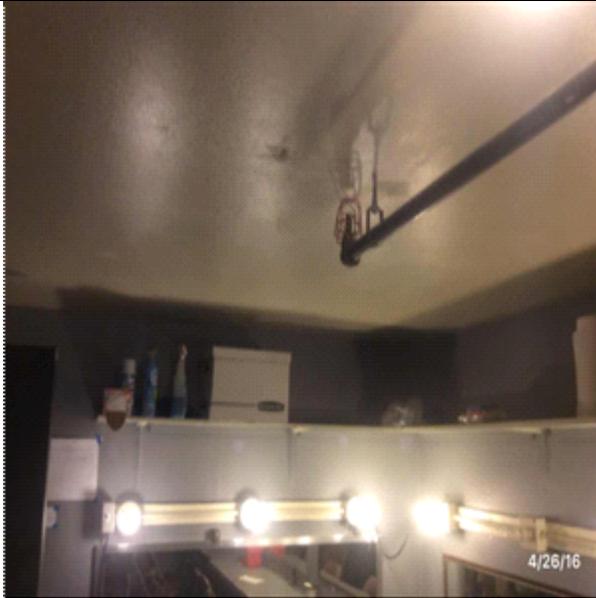
The sprinkler system was observed to be in fair condition. No visible corrosion or leaks were observed. We do not anticipate any work within the cost study period, except for regular maintenance and testing of the system.

D4011 Sprinkler Water Supply:- View of Wet-Pipe Sprinkler System

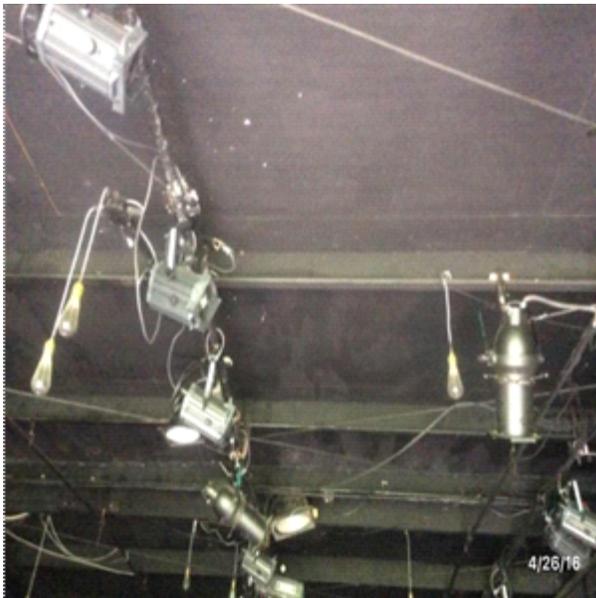
D5022 Lighting Equipment:- View of Interior Light Fixtures - Incandescent
